LITTLE MALVERN PRIORY

ORGAN RESTORATION REPORT

JUNE 2019

NICHOLSON & CO. LTD

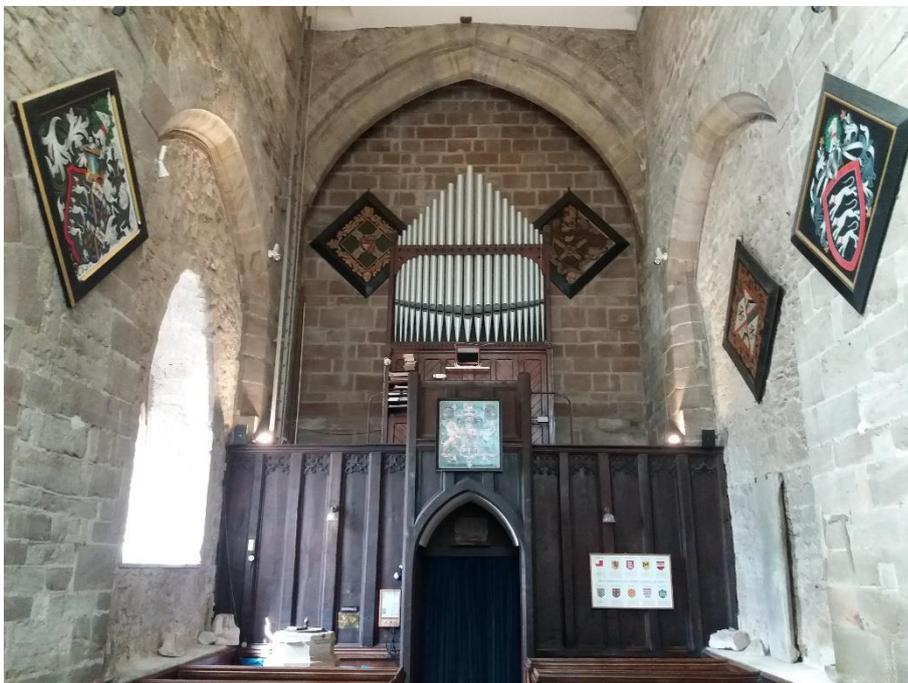
The organ was in regular weekly use, but was becoming increasingly troublesome mechanically. Much wear in the mechanical action had made the mechanism noisy. Wind leakage was considerable. The primary cause for concern was the condition of the Swell Organ soundboard, which was beset with severe murmuring (notes sounding faintly when stops were drawn but no keys were depressed). The pipework was grubby but in fairly good physical condition.

The case and console woodwork remained structurally sound but were in very poor aesthetic condition. The wear and tear of many decades paled into insignificance against the grave damage caused by the wholly inappropriate routing of electrical wires and switches, not to mention the fixing of a hasp and staple, over many years.

Pre-restoration

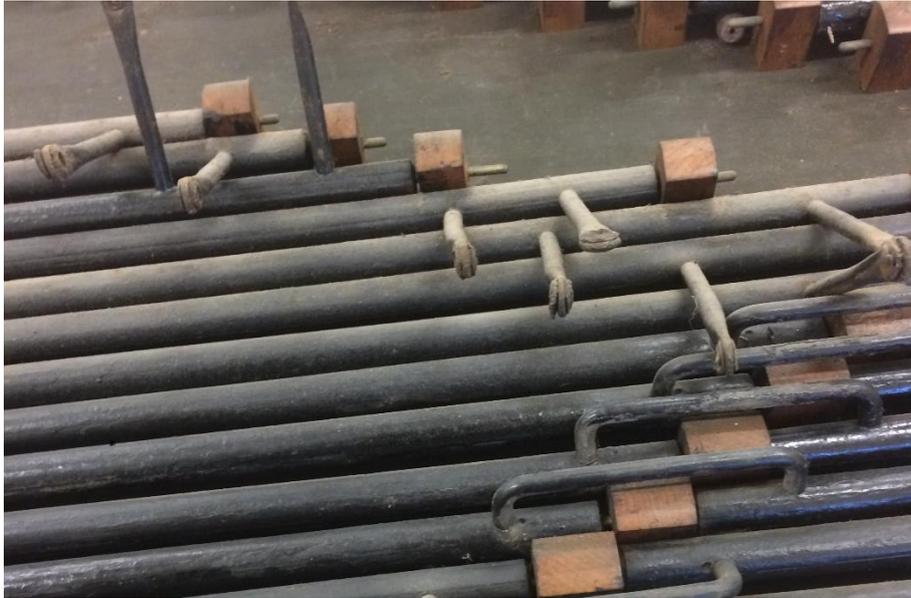
The manual and pedal key actions are entirely mechanical, and their restoration was straightforward. The trackers were generally in good condition and the original steel wires had been replaced with new of phosphor-bronze in our 1934 overhaul. Square beams, backfalls and rollerboards were worn. These have been thoroughly restored and re-bushed using matching material to original, including new leather bushings in all of the roller arms³. New cloths and leather buttons have been fitted throughout. The pedal coupling rollers are metal, whereas the soundboard rollers are of wood. In accordance with accepted conservation principles for such components, metal roller arms have been rubbed down and repainted to match the original colour.

Rollerboard pre-restoration

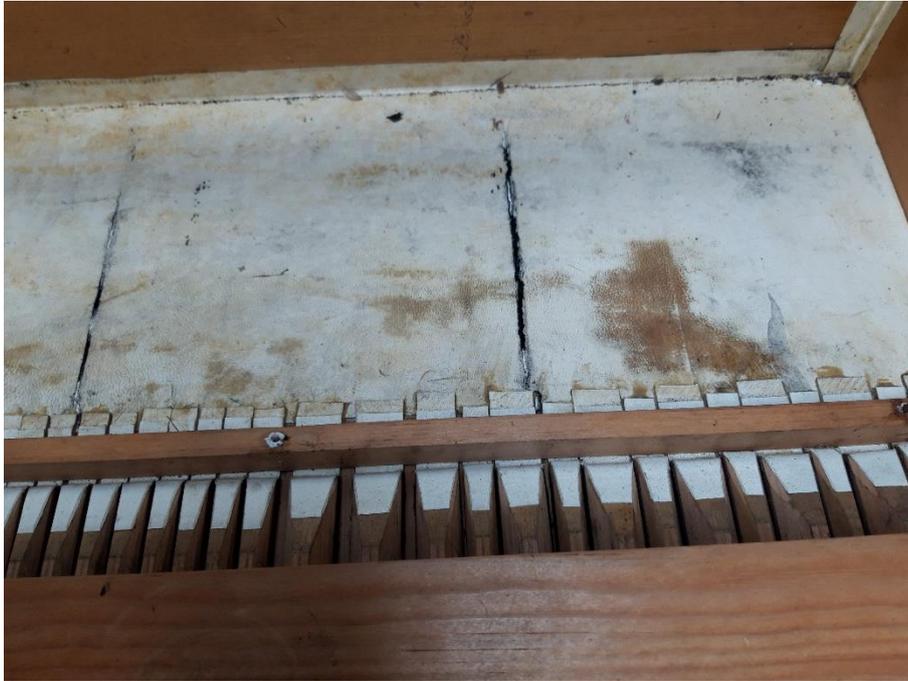
Badly split leather covering on underside of soundboard

Most organ builders make the top of the well flush with the top of the grid, to allow the table to be of one piece of timber covering the entire surface of the soundboard. In both of these soundboards, however, the well tops protruded beyond the top of the grid and the table was recessed between. This means that that the top of the soundboard is formed of three pieces of timber rather than one, with a much greater propensity to structural problems. On the Swell Organ soundboard, the table had come apart from the well and grid, causing significant murmuring.

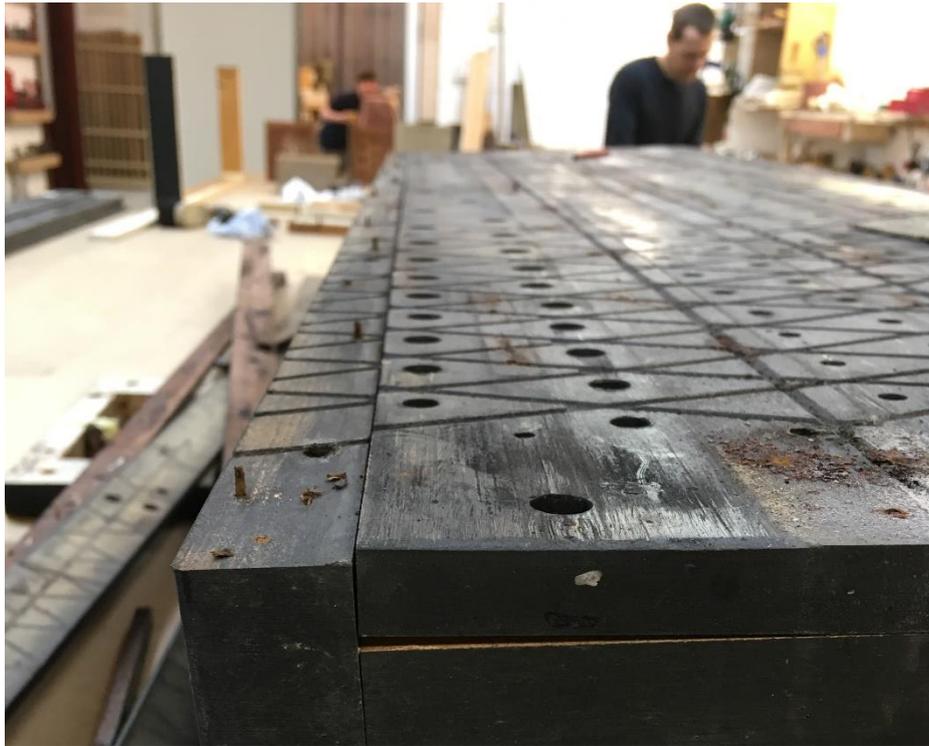
Serious structural problems on Swell Organ soundboard

The dire condition of the Swell Organ soundboard necessitated the unusual step of complete disassembly of the soundboard during restoration.

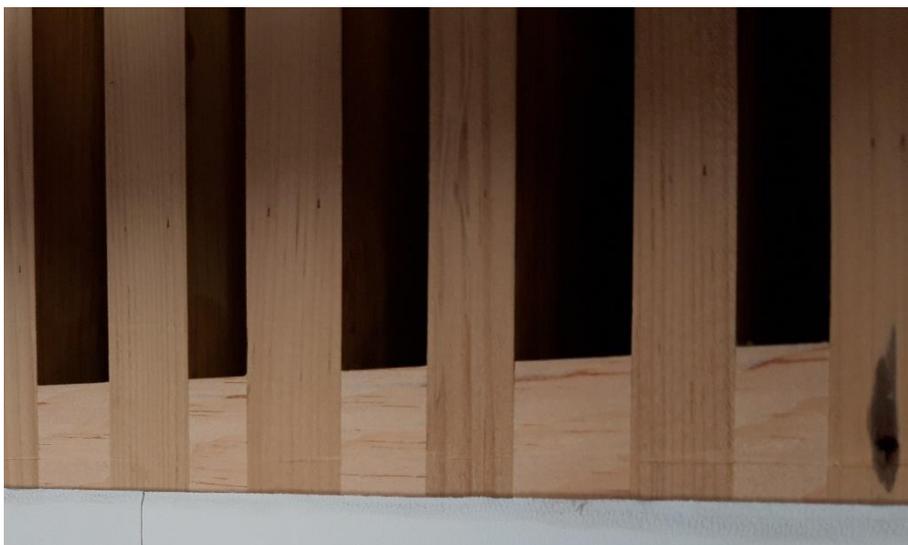
standard practice to make and locate such infills so that their grain is perpendicular to that of the bars. This minimises the likelihood of such infills coming loose through humidity related expansion and contraction. The infills in both soundboards were, however, made and located with the grain parallel to the bars; the consequence of this was that many were finger loose and some were no longer gripped at all by the bars, which was one cause of the numerous malfunctions in the soundboards pre-restoration.

New infills with grain perpendicular to bars

We felt that this was a sufficiently serious manufacturing flaw, with a high likelihood of recurrence, that we replaced all of the infills with new, with their grain perpendicular to the bars. Matching timber was used.

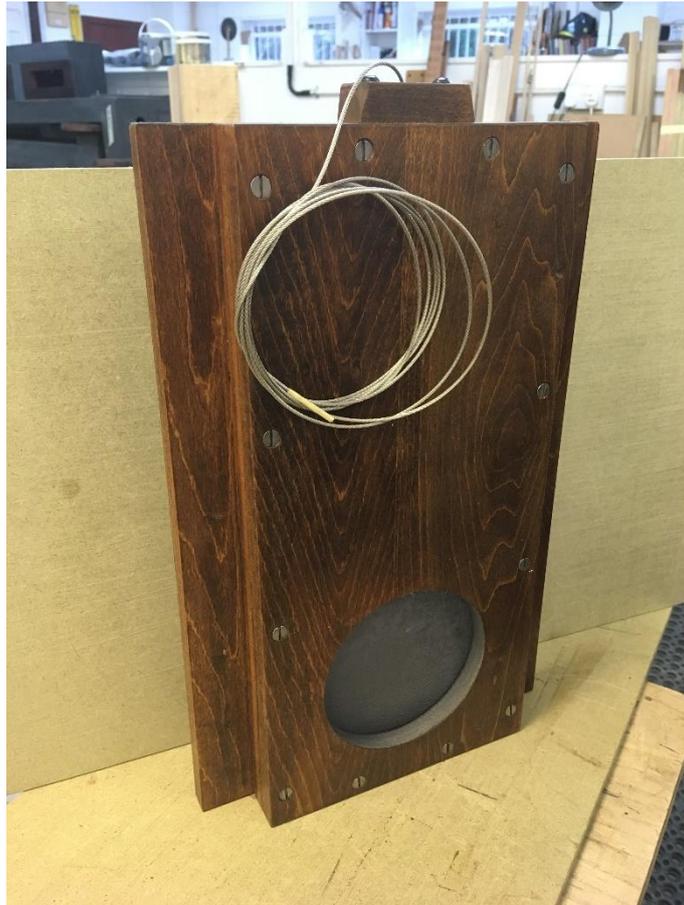
The plywood wind control fitted to the reservoir in 1967 was found to be badly affected by woodworm and has been replaced with new of solid timber, stained to match its surroundings.

New wind control

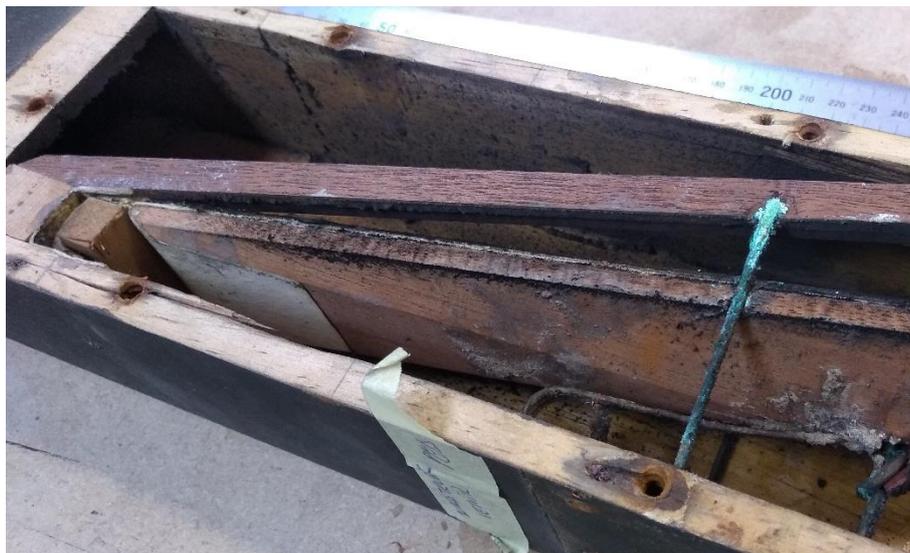
The vent for the Bourdon chests was striking for its poor original construction, having been secured to the wind trunk in wood so thin that the screws had split the surrounding timber. We have therefore re-made the vent and the surrounding part of the trunk; in style and material the new work is an exact replica of the original, except for slightly thicker timber around the screw holes.

Original vent - note burst screw holes

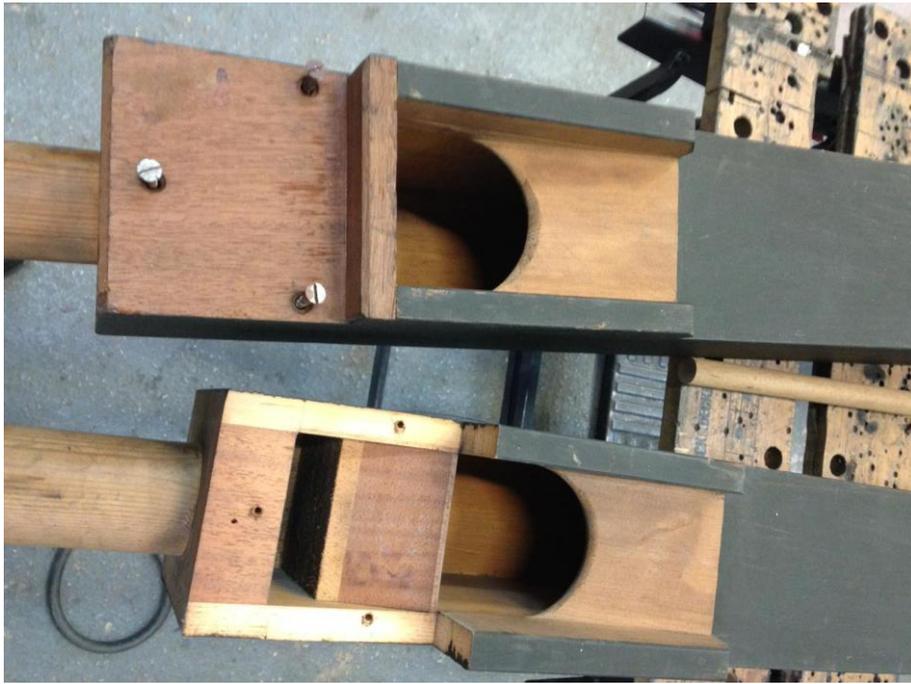
Repairing split caps on Bourdon pipes

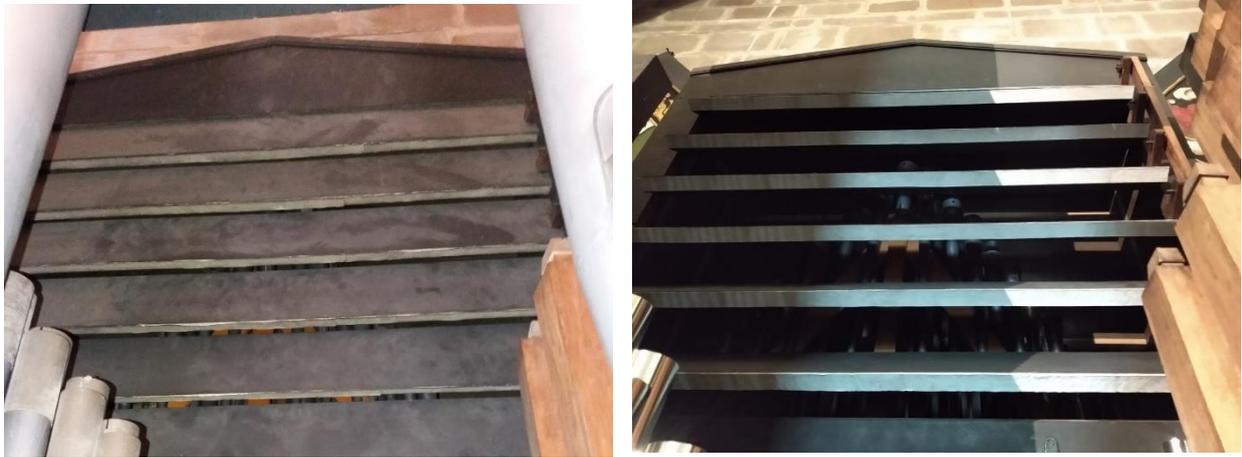
One dilemma that we faced was what to do about the poor opening of the shutters. Notwithstanding the normal wear found in the mechanism, the extent of shutter opening when the lever expression pedal was fully depressed was astonishingly small. This made the Swell division sound somewhat muffled and very much an also-ran to the – by comparison – brilliance of the Great division. Our assessment was that this was an original manufacturing/installation flaw that had never been put right, rather than something that had arisen over time or even that the original builders intended.

Shutters with pedal in fully open position: pre-restoration (left) and post-restoration (right)

A vital mainstay of historical restoration is that organ builders should seek to respect and restore the original builder's concept, and not to alter historical instruments to suit modern tastes. This can be difficult for organ builders who normally try to ensure that everything that leaves their bench is as good as it possibly can be. After careful consideration, we felt that documented alteration to the expression mechanism was necessary and reasonable, and we therefore replaced one part of the mechanism rodding with new that incorporated some gearing to increase the shutter opening distance to 45°. This has greatly improved the tonal versatility of the instrument. The original rodding has been stored inside the organ.

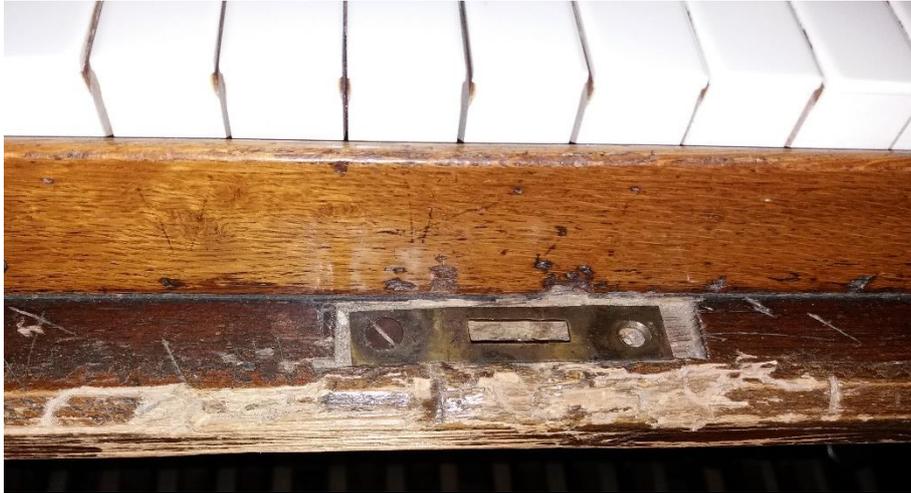
The casework is of pine and was in a dire condition. Very considerable damage had been sustained through the inappropriate routing of electrical cables and fittings over the years. The damage was so severe that the only appropriate course of action was to cut out the damaged sections, piece in new timber, and then strip and re-finish all the timber afresh.

Console damage

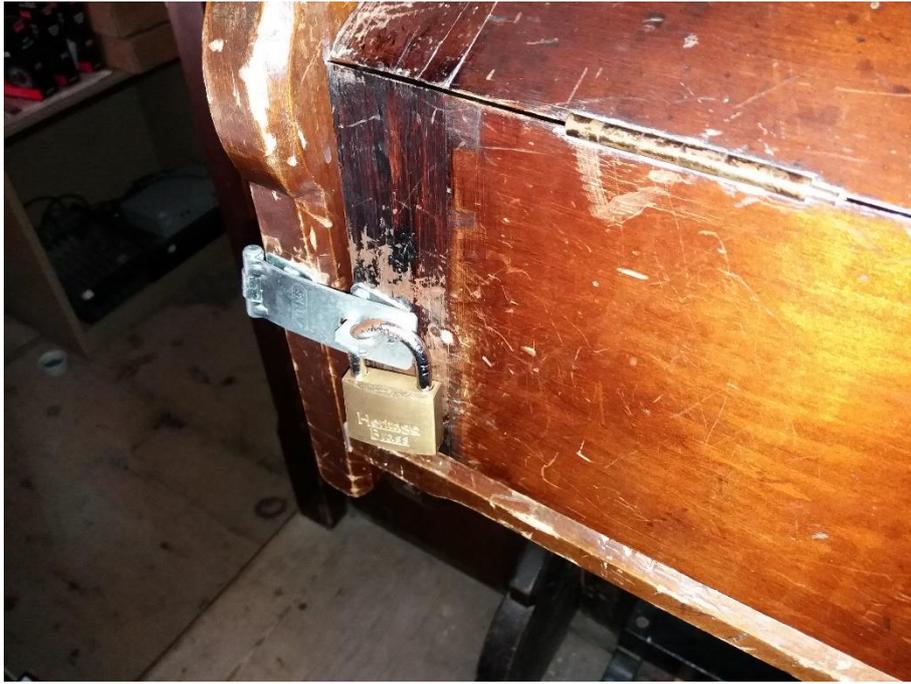
Console damage

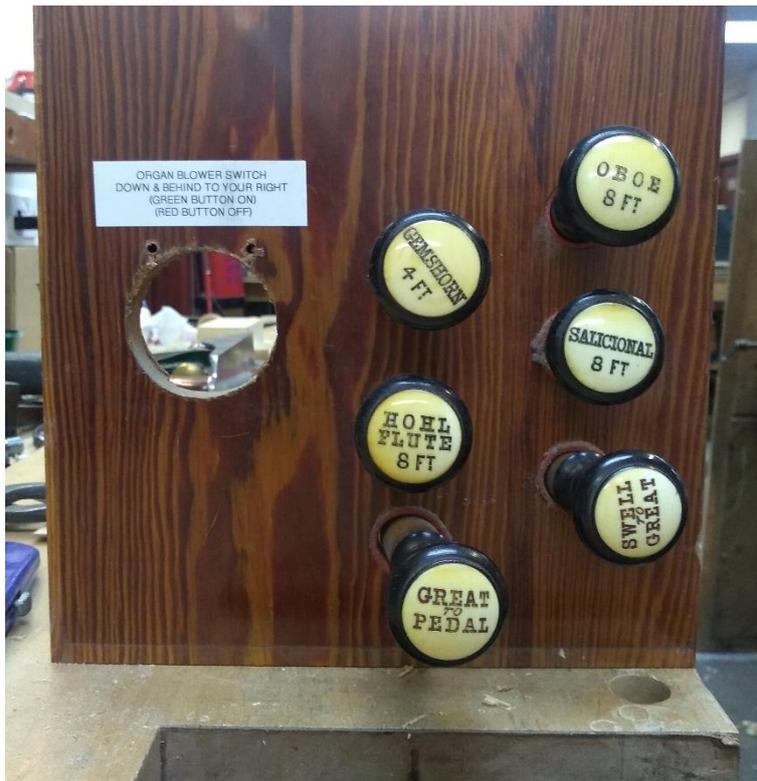
Hole drilled in stopjamb for a since-removed blower switch
