LITTLE MALVERN PRIORY

ORGAN RESTORATION REPORT

JUNE 2019

NICHOLSON & CO. LTD

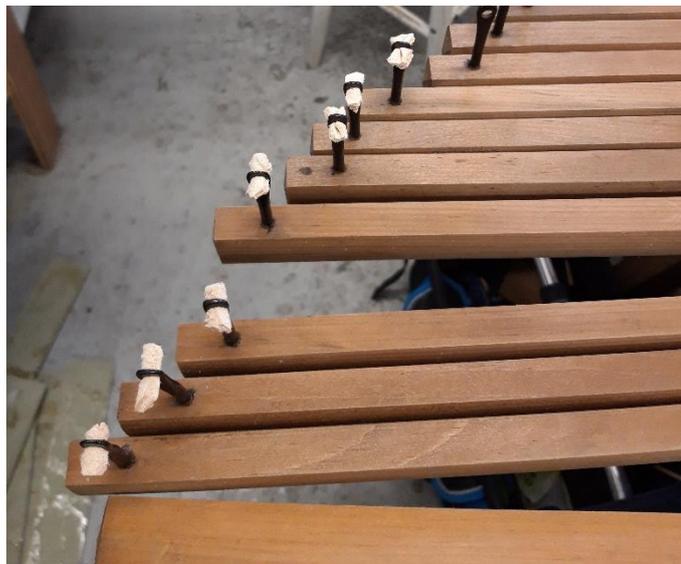
The manual and pedal key actions are entirely mechanical, and their restoration was straightforward. The trackers were generally in good condition and the original steel wires had been replaced with new of phosphor-bronze in our 1934 overhaul. Square beams, backfalls and rollerboards were worn. These have been thoroughly restored and re-bushed using matching material to original, including new leather bushings in all of the roller arms³. New cloths and leather buttons have been fitted throughout. The pedal coupling rollers are metal, whereas the soundboard rollers are of wood. In accordance with accepted conservation principles for such components, metal roller arms have been rubbed down and repainted to match the original colour.

Fitting new leather bushes to roller arms

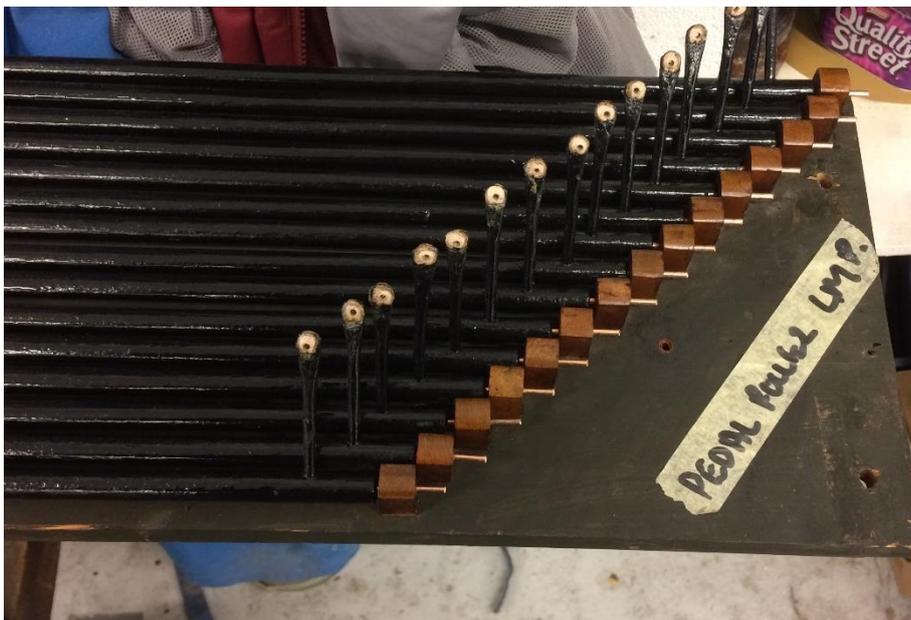
Rollerboard post-restoration

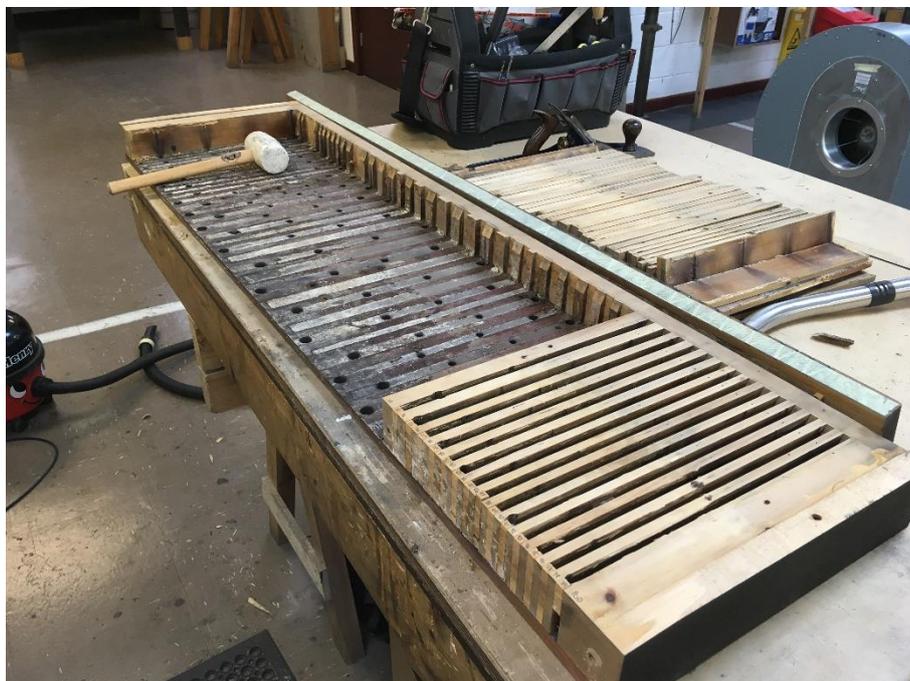
The dire condition of the Swell Organ soundboard necessitated the unusual step of complete disassembly of the soundboard during restoration.

Swell Organ soundboard being taken completely apart

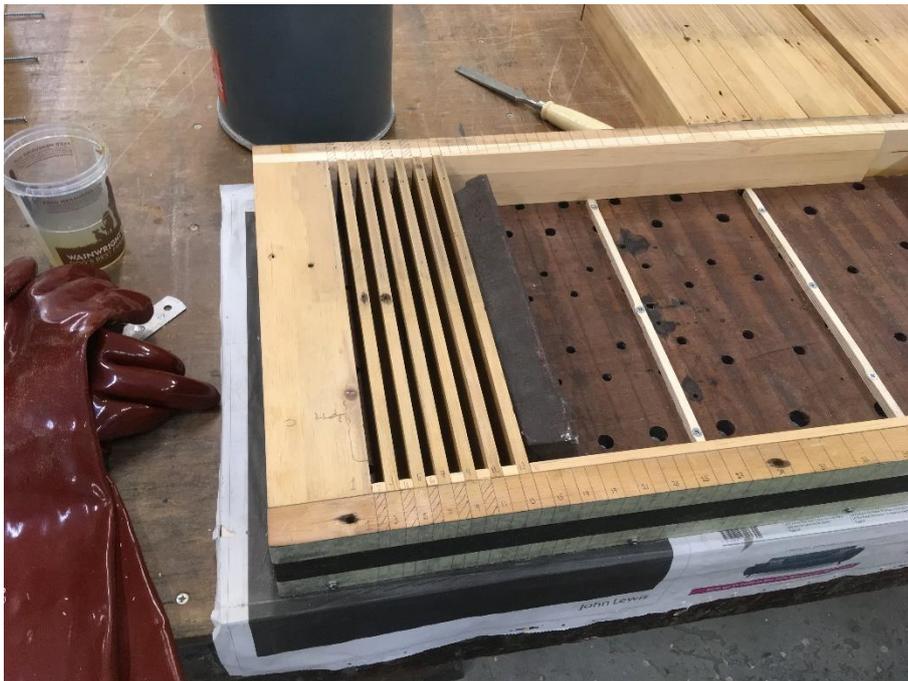
standard practice to make and locate such infills so that their grain is perpendicular to that of the bars. This minimises the likelihood of such infills coming loose through humidity related expansion and contraction. The infills in both soundboards were, however, made and located with the grain parallel to the bars; the consequence of this was that many were finger loose and some were no longer gripped at all by the bars, which was one cause of the numerous malfunctions in the soundboards pre-restoration.

Assembling soundboard again with new infills

We felt that this was a sufficiently serious manufacturing flaw, with a high likelihood of recurrence, that we replaced all of the infills with new, with their grain perpendicular to the bars. Matching timber was used.

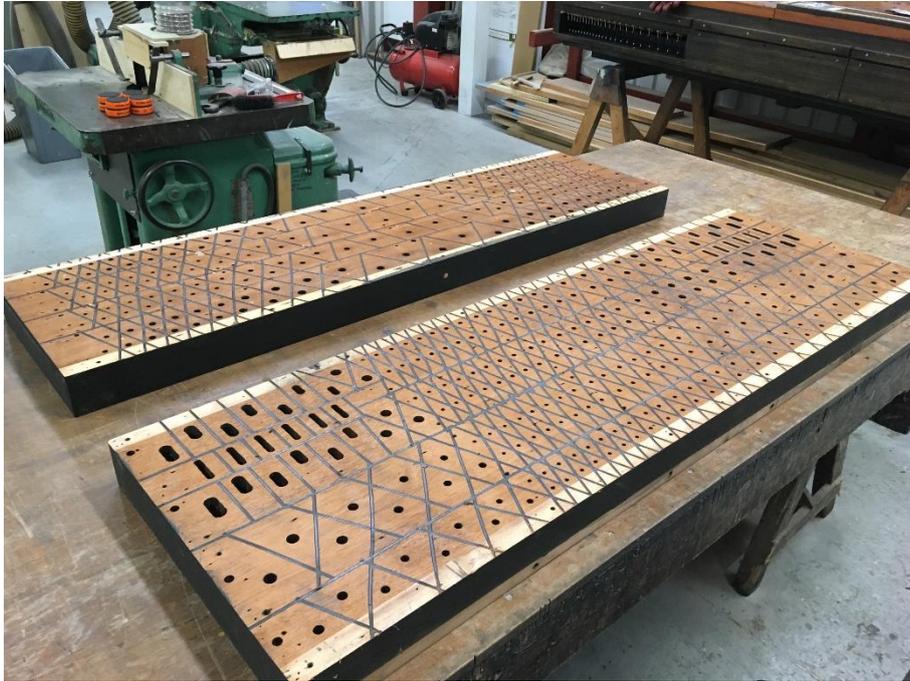
Restored soundboards ready for glue flooding

Upon re-assembly, the remainder of the restoration work was conventional and straightforward. The table was planed flat, grooves were deepened slightly as required, the bearers re-papered, and both soundboards flooded with hot animal glue.

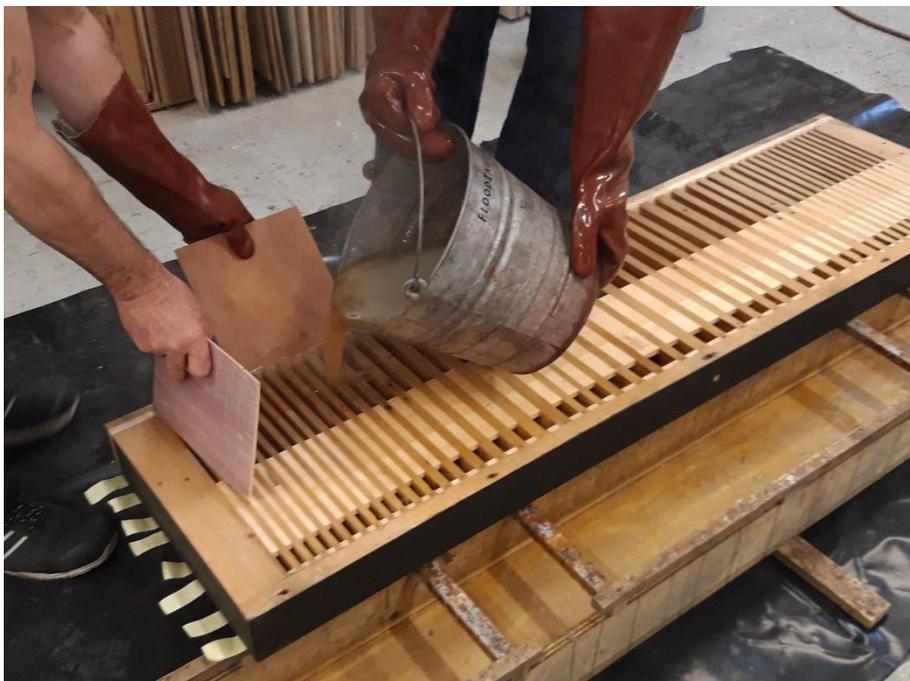
Hot glue flooding of Swell Organ soundboard

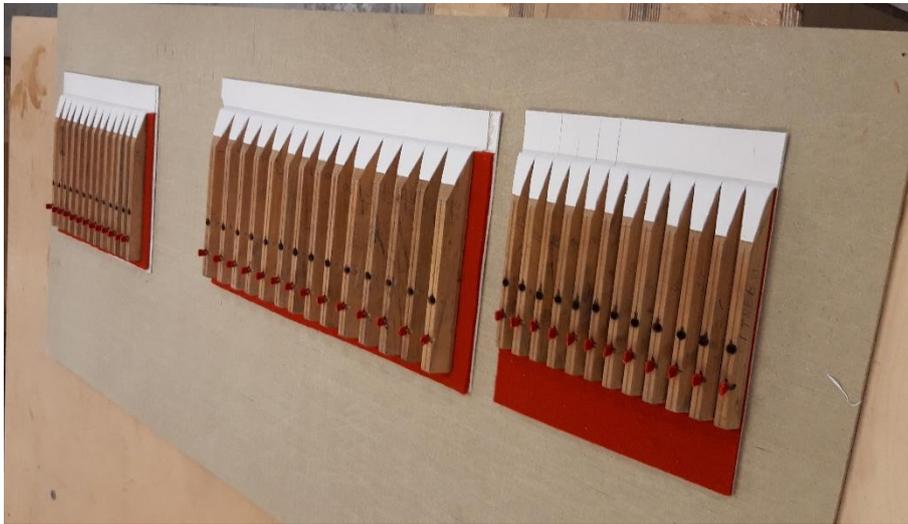
Pallets being covered with new felt and leather

common for Hill & Son to cover pallets in a double layer of leather, but in the absence of definitive information otherwise, we have repeated here what we found: felt and leather.

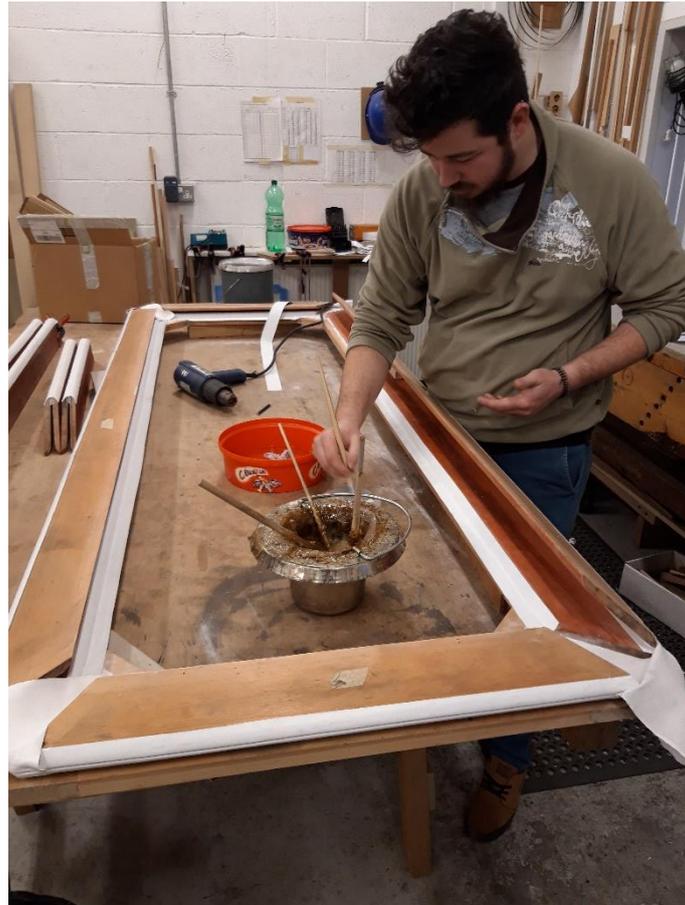
The leatherwork on the double-rise reservoir at the base of the organ was in poor condition although mostly still - just - windtight. We have no documentary evidence that it had ever been re-leathered - it was certainly not undertaken in either our 1934 or 1976 overhauls, but its condition was remarkable if the leather was indeed original. It has been entirely re-leathered in the course of the present work. The redundant and disconnected feeders have been left unrestored, attached to the underside of the restored reservoir, as an historical feature. The inlet valves into the reservoir from the feeders have been covered over inside the reservoir with plywood board in a reversible manner.

Reservoir re-leathering underway, using hot animal glue

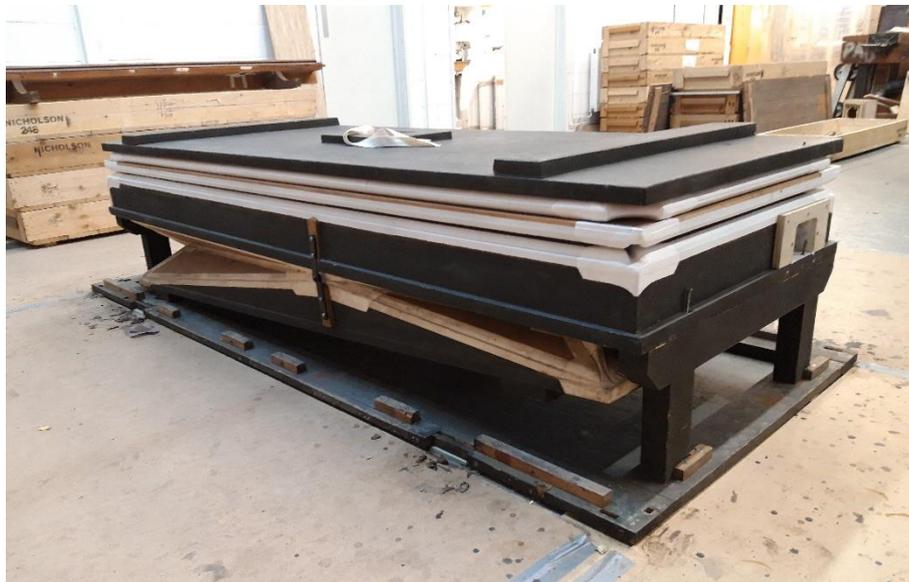
Restored reservoir, with obsolete and unrestored feeders left in situ as artefacts

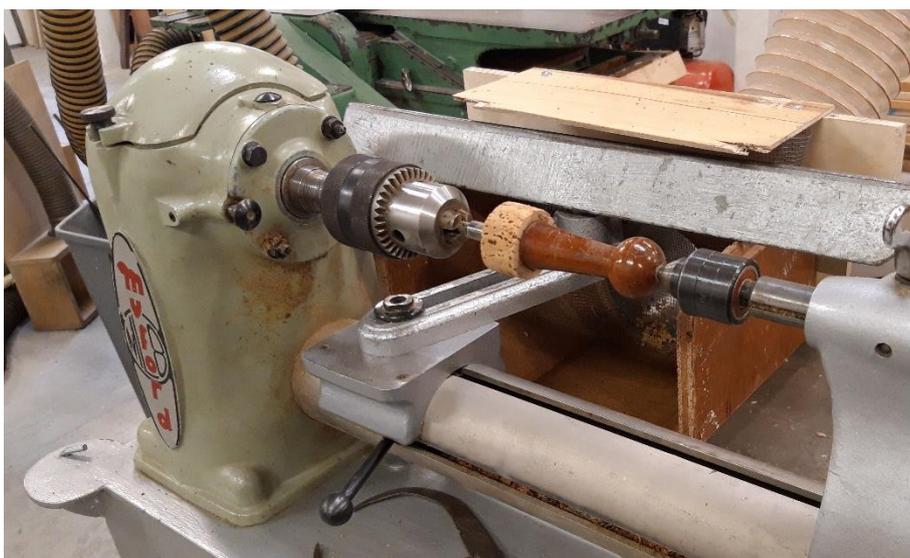
The pipework was dirty but in good physical condition. The cork lining of the stoppers on the Gedact 8' stop had perished and begun to disintegrate. New cork stopper linings were turned to fit⁴.

Turning new cork stoppers on the lathe

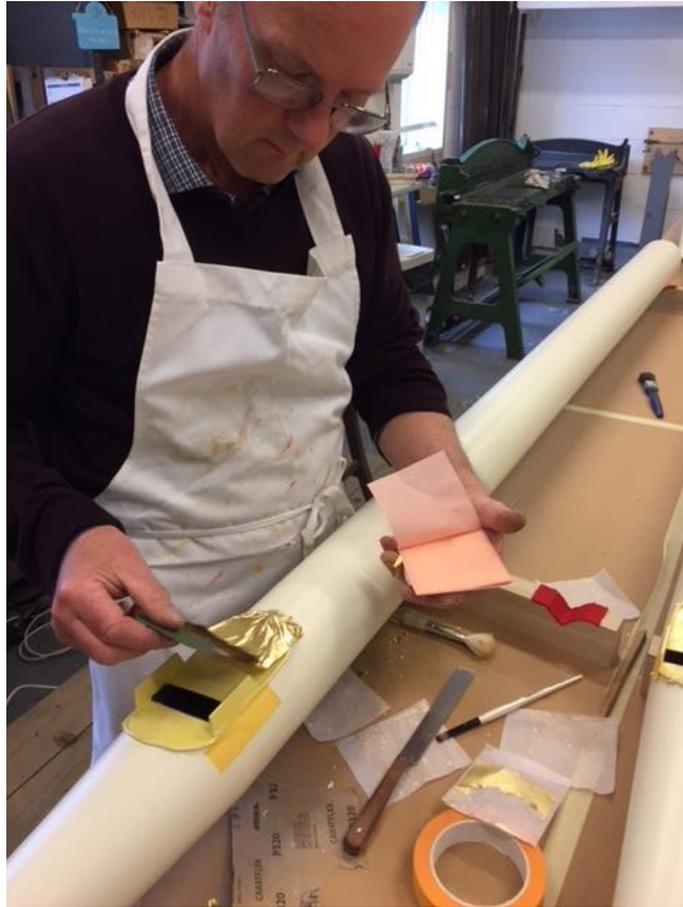
The façade pipes had been painted silver at some stage. The paintwork was tarnished and in poor condition. We were anxious to try to identify how the façade pipes had been finished originally. Careful investigation and stripping of paint on one pipe revealed no sign of any previous decoration. We therefore suggested to the church that we could either strip all the façade pipes bare, back to their original state, or to repaint them afresh. The church elected to have them repainted; Farrow & Ball Lime

Gilding pipe mouths

White No. 1 was chosen! Two coats of primer and two top coats have been applied. We have also gilded the mouths.

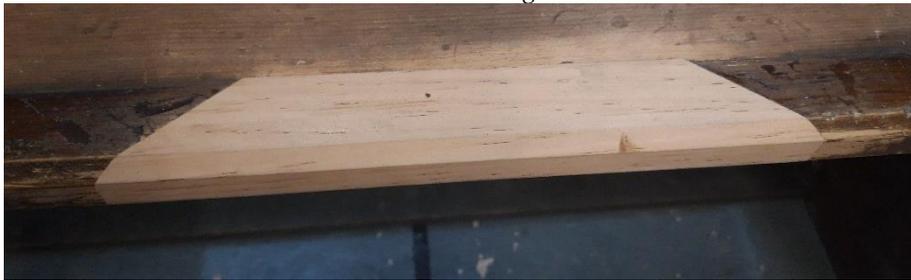
The casework is of pine and was in a dire condition. Very considerable damage had been sustained through the inappropriate routing of electrical cables and fittings over the years. The damage was so severe that the only appropriate course of action was to cut out the damaged sections, piece in new timber, and then strip and re-finish all the timber afresh.

New timber pieced in

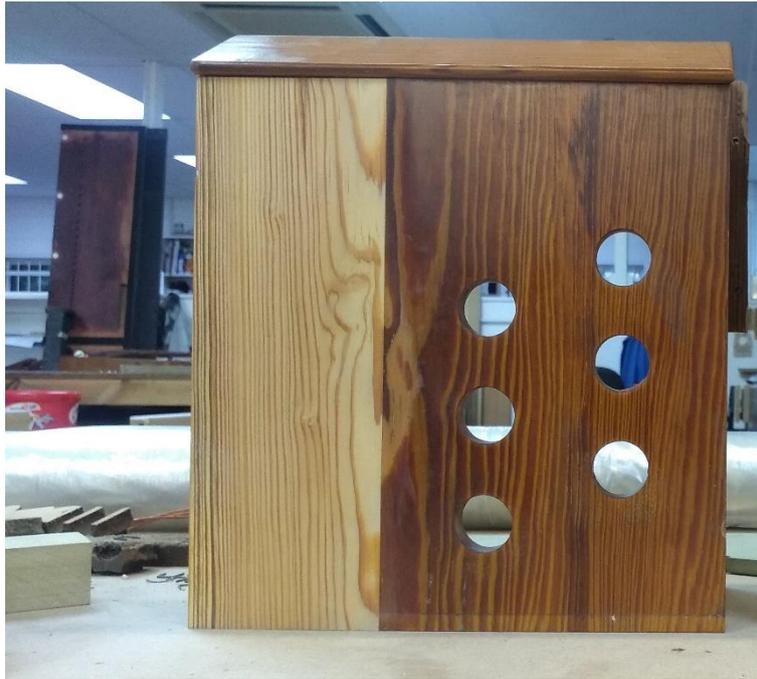
New timber pieced in

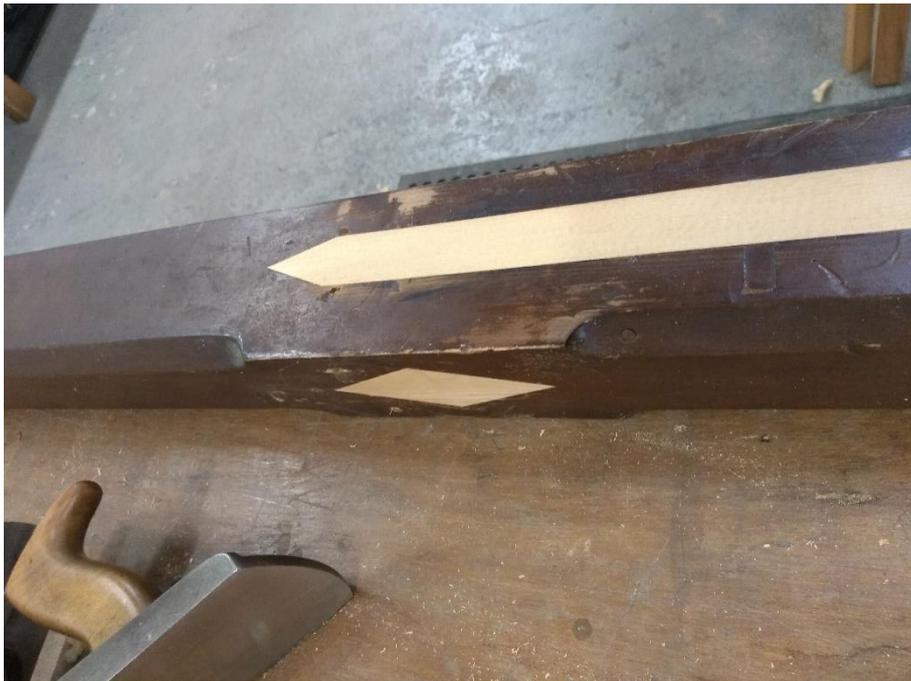
More timber pieced in to repair electricians' damage

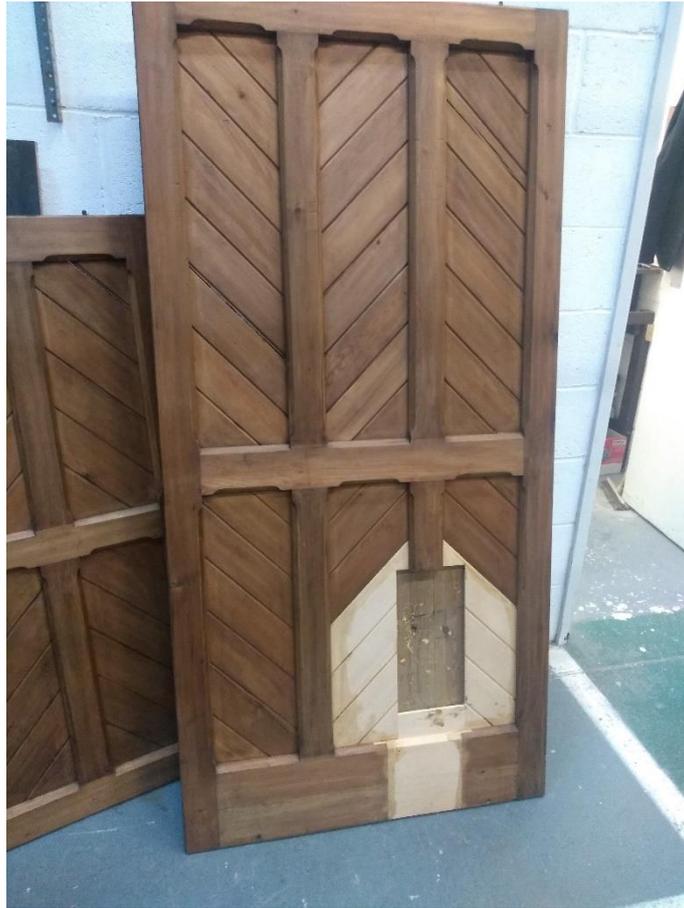
Side panel stripped with new infill
